**Stability Evaluation of Little Tunnel, Cumberland Gap, Tennessee.**

**Report by Golder Associates, May 1986.**

### **STABILITY EVALUATION OF LITTLE TUNNEL CUMBERLAND GAP, TENNESSEE**

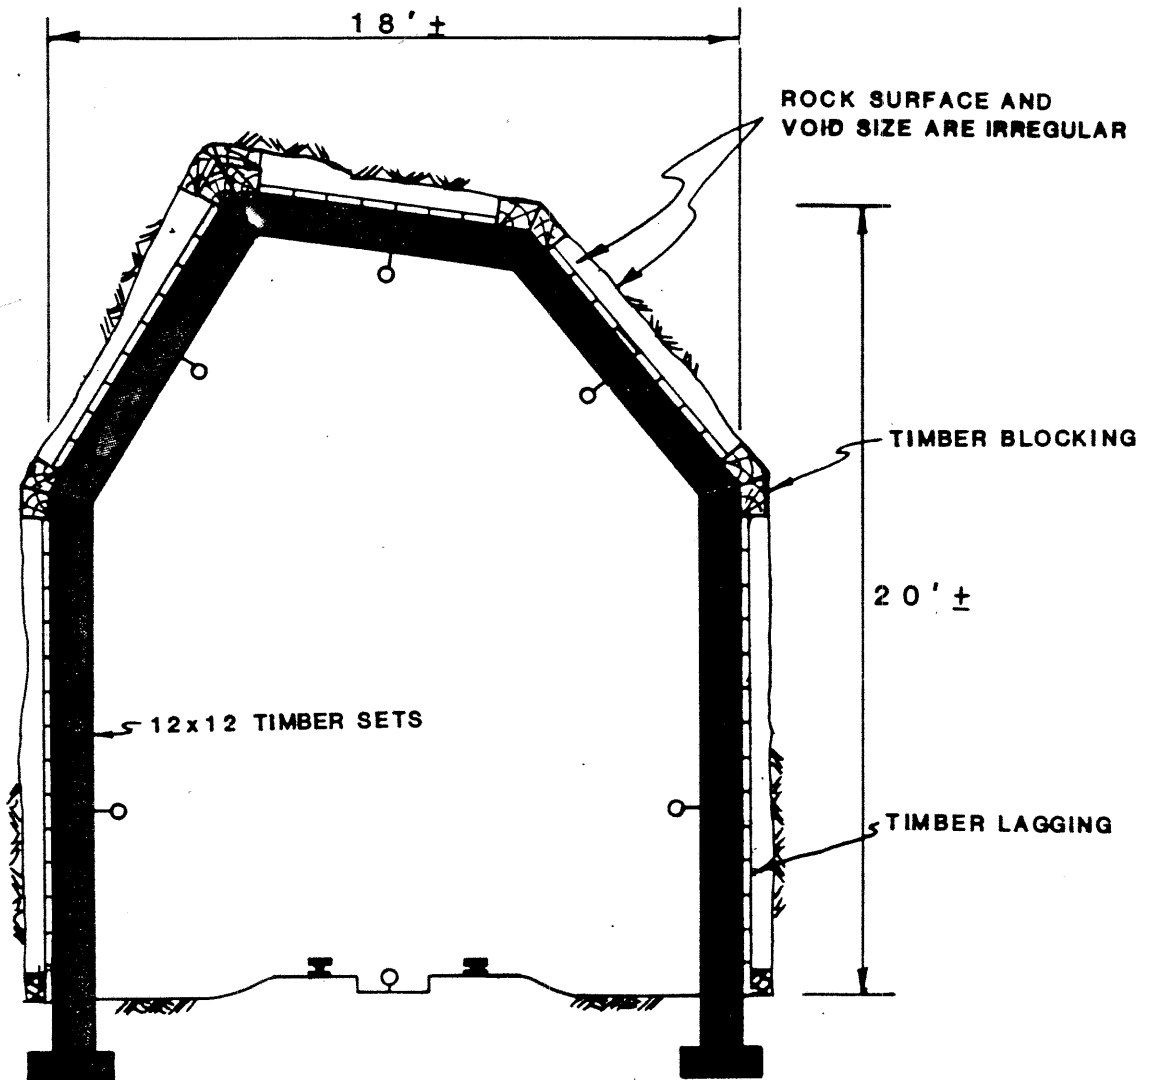
JOB NO. 853-3256	SCALE 1" = 5'	TYPICAL TIMBER SUPPORTED SECTION	
DRAWN SKB	DATE 2-14-86		
CHECKED	DWG. NO.		
Golder Associates		LEE WAN & ASSOCIATES	FIGURE 2

The timber support consists of 12 in. X 12 in. timber sets placed at 4 ft. on centers and 3 in. X 9 in. timber lagging. A typical cross section of a timber sets is provided in Figure 2. The practice of the day was to block the sets to the rock at the miter joints using timber cribbing. For safety reasons, we were able to actually observe the cribbing at only a few locations where it could be seen through openings in the lagging. Thus, the actual locations and conditions of the cribbing remain unknown.

The rock was observed to be tight against the lagging in some places, while voids up to 4 ft. deep were seen in other places. Typically, the void between the lagging and the rock was larger above the haunches and crown than behind the walls.

Typically, the timber sets and lagging are rotted on the surface but otherwise appear to be sound and capable of carrying near their original capacity. Localized splitting of the timber sets was frequently observed. The splits usually extend an inch or less into the sets and do not appear to appreciably affect their load carrying ability. Where an intermediate level of deterioration is shown in Figure 3, the set's load carrying capacity was judged to be reduced but is still substantial. Where severe deterioration is indicated, the timber is considered to retain a minimal load carrying capacity and additional support is required.

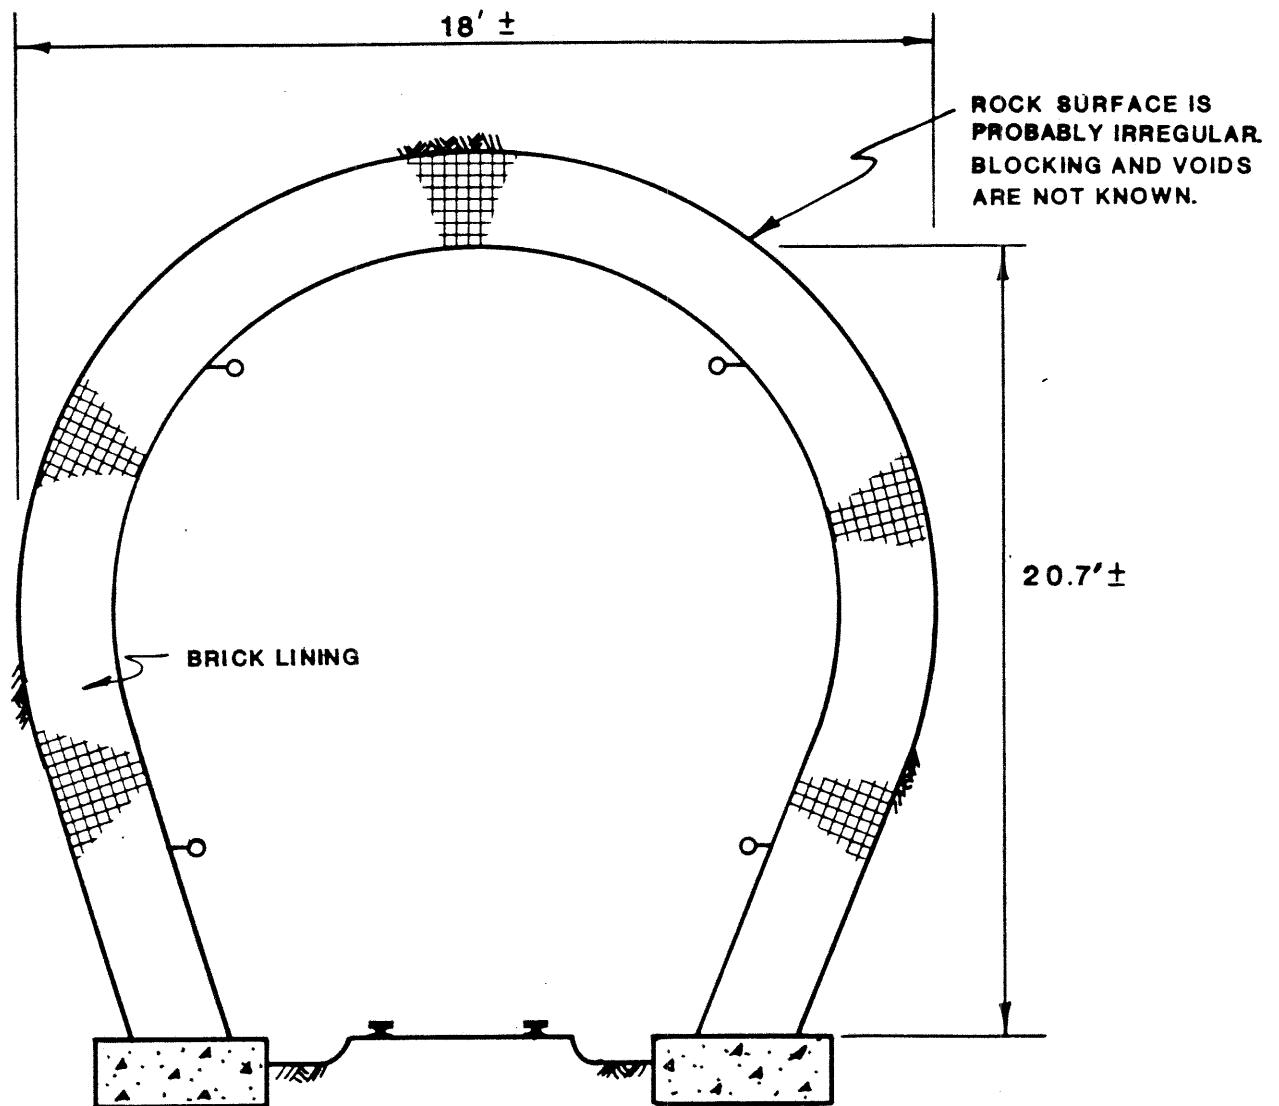
JOB NO. 853-3256	SCALE N.T.S.	TYPICAL BRICK SUPPORTED SECTION	
DRAWN SKB	DATE 2-14-86		
CHECKED	DWG. NO.		
Golder Associates		LEE WAN & ASSOCIATES	FIGURE 4

The brick lining is horseshoe shaped, with sides that curve inward, as shown in Figure 4. The thickness of the lining and the contact it makes with the rock can be seen only at the end of the brick lining inside the tunnel. There it has a minimum thickness of 2.1 ft. and is thicker where it was necessary to fill in irregularities in the rock. Timber cribbing is also visible in the larger irregularities. The overall width and height of the brick lining is about the same as the timber supports. This suggests that any timber sets placed during original tunnel excavation were removed as the brick lining was erected.

The brick lining is in excellent condition. Both bricks and mortar remain hard. No cracks larger than hair-line in width were observed, and no active seepage was observed. There was evidence of slight seepage in the form of a light colored precipitate on the brick in some areas. The crack-free condition of the brick also suggests that the lining was built tightly against the rock. If it had not been, rock loading would almost certainly have induced moments in the brick lining at some locations and caused it to crack.
